Sanitary surveys

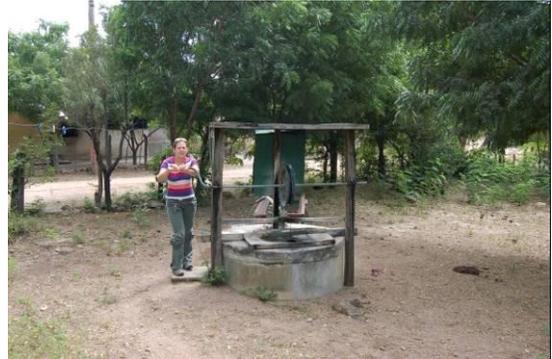
Name:	Catalina Rivas
Approx. depth (m):	~10 m
Closest latrine (m):	30 m
Well type:	Hand dug with concrete surround
Pump type:	Unprotected rope pump
Cover:	Concrete cover slab
Drainage:	No drainage but well pumps into a trough

as the most reliable source from a microbiological perspective. Measures which could be taken to improve drinking water quality from contaminated wells include improvements to well protection, drainage aprons and pumps, as well as the promotion of water filters which could significantly improve the water from wells registering more than 10 E. coli/100 ml. The most appropriate system for this type of community is the 'Filtron' ceramic filter. The successful introduction of water filters would depend on a well-organised education campaign and adequate follow-up over a number of months.

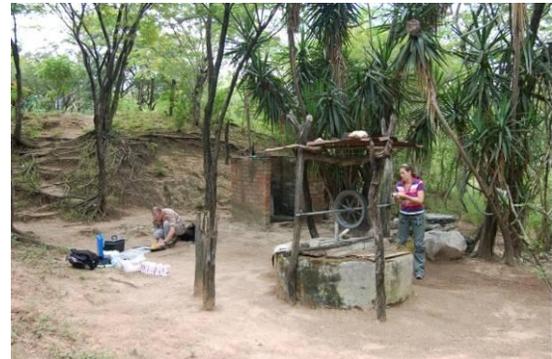
Name:	Ronald Rivas
Approx. depth (m):	~7 m
Closest latrine (m):	>30 m
Well type:	Hand dug with concrete surround
Pump type:	Unprotected rope pump
Cover:	Zinc/wood, well fitting
Drainage:	Natural drainage

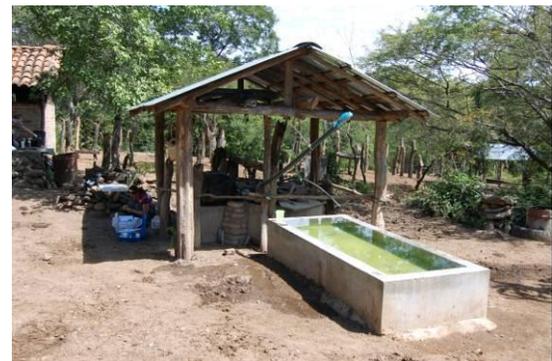
Name:	Faustino Rivas
Approx. depth (m):	Unknown
Closest latrine (m):	20 m
Well type:	Hand dug with concrete surround
Pump type:	Diesel pump
Cover:	Zinc, well fitting
Drainage:	No drainage - muddy

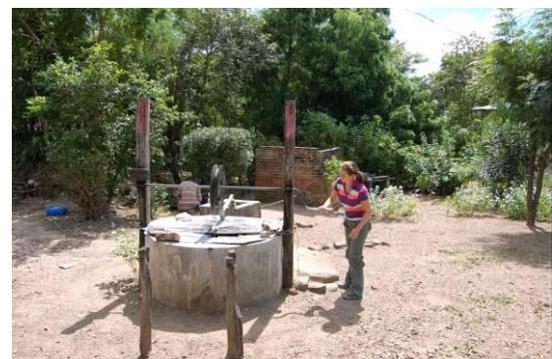
Name:	Transito Matamoro
Approx. depth (m):	~10 m
Closest latrine (m):	>30 m
Well type:	Hand dug with concrete surround
Pump type:	Unprotected rope pump
Cover:	Zinc, well fitting
Drainage:	No drainage but not wet

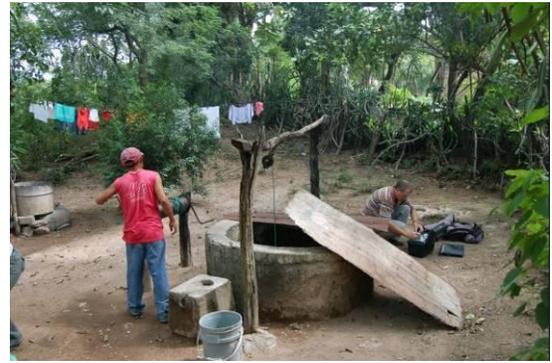
Name: Vicente Matamoro
Approx. depth (m): ~10 m
Closest latrine (m): 20 m
Well type: Hand dug with brick surround
Pump type: Bucket and windlass
Cover: Zinc, opened to draw water
Drainage: No drainage but not wet

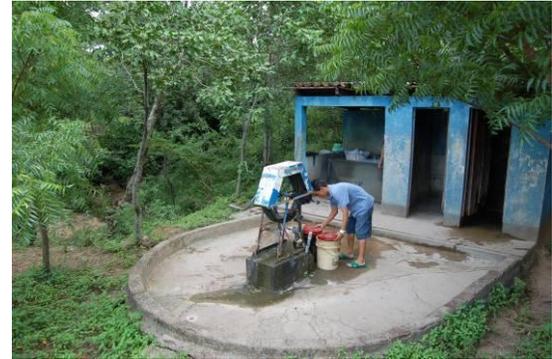
Name: Communal well
Approx. depth (m): Unknown
Closest latrine (m): ~10 m (4 school latrines uphill)
Well type: Borehole (drilled by CARITAS)
Pump type: Unprotected rope pump
Cover: Concrete well head
Drainage: Good concrete apron

The wells at El Cacao are typical of rural communities in Nicaragua in terms of their construction, levels of hygiene and faecal contamination. The communal well appears to be the most reliable water source within the community and in order to reduce waterborne disease, this should be recommended

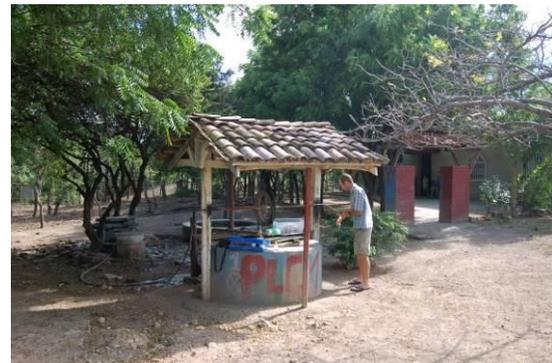
Name: Fabio Espinoza
Approx. depth (m): Unknown
Closest latrine (m): >30 m
Well type: Hand dug with concrete surround
Pump type: Unprotected rope pump
Cover: Zinc cover and tiled roof
Drainage: No drainage or trough
